# RICE LAKE BARRON COUNTY

## 2023 MANAGEMENT SUMMARY REPORT WBIC: 2103900

Prepared by: Dave Blumer, Lake Educator

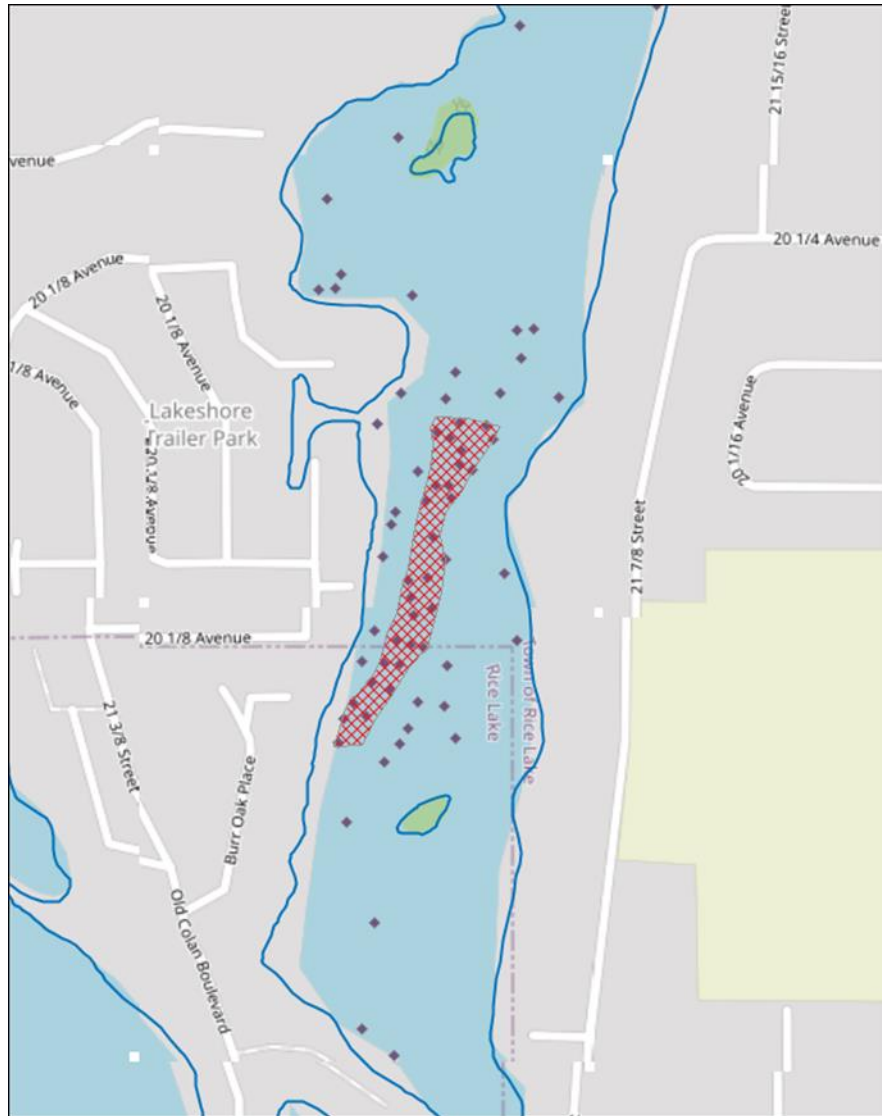
**Figure 1: Preliminary 2023 herbicide application proposal in Clearwater Bay (this was not completed)**

Preliminary HWM management planning for 2023 included more physical and diver removal of individual plants in both Clearwater Bay and the South Basin. A small chemical treatment of one area of Clearwater Bay totaling 2.8 acres was also proposed (Figure 1). After a discussion with the WDNR, it was determined that this chemical application proposal would not likely be permitted, due to chemical treatments completed in Clearwater Bay in 2022, so it was not completed.

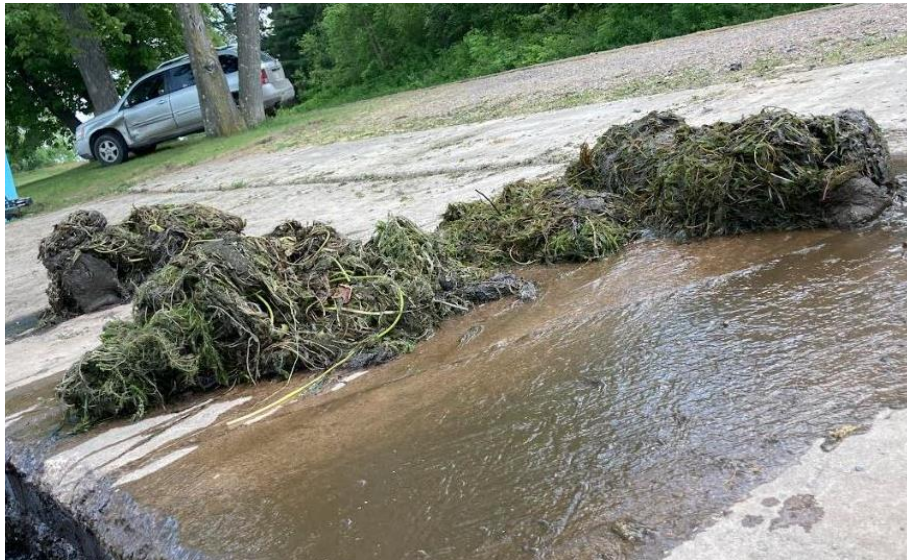
Figure 2: HWM removed on May 31 by free diving. Removed HWM was dumped at the aquatic plant harvesting dump site off Lakeshore Dr.

HWM was physically removed from the South Basin on three different dates in 2023 – May 31, June 8, and June 20. Between the three dates, 16.5 hours of removal time was logged and at least sixteen 18-gallon totes of HWM were removed (Figures 2&3). After the third free diving event, the dive team reported that any more removal was likely pointless because there was too much!

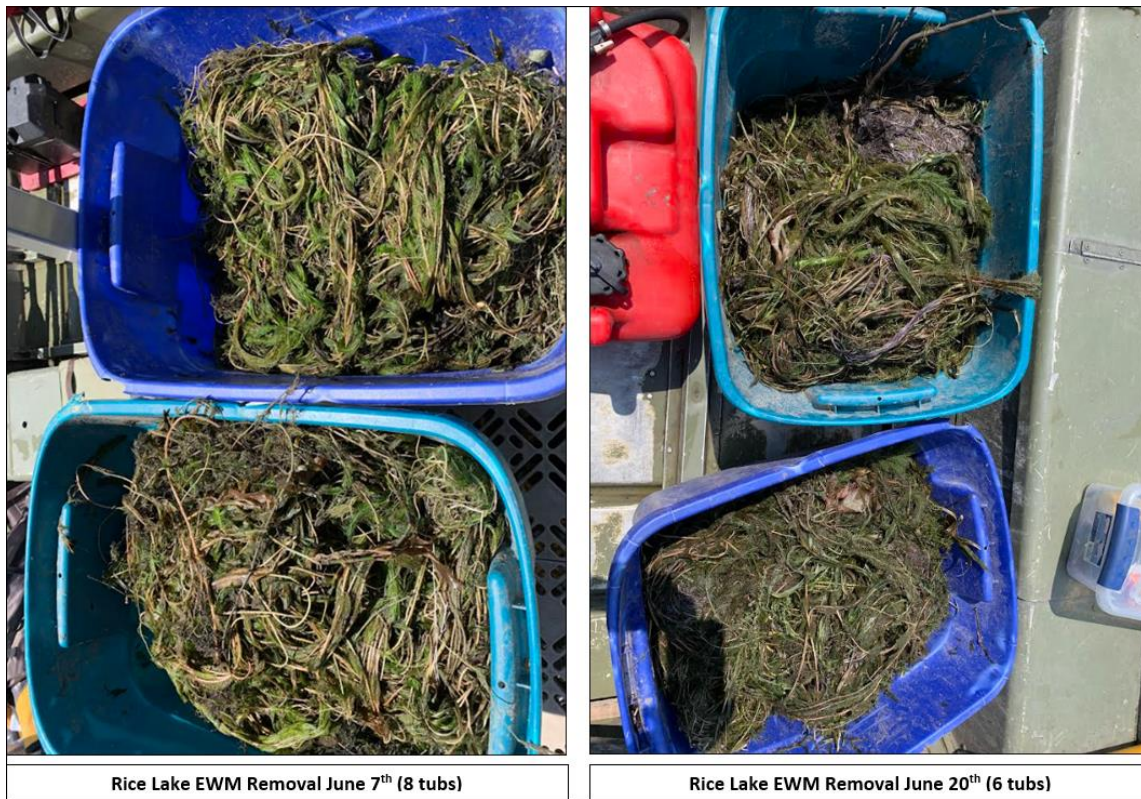
Figure 3: A portion of the HWM removed June 8<sup>th</sup> and 20<sup>th</sup> by free diving

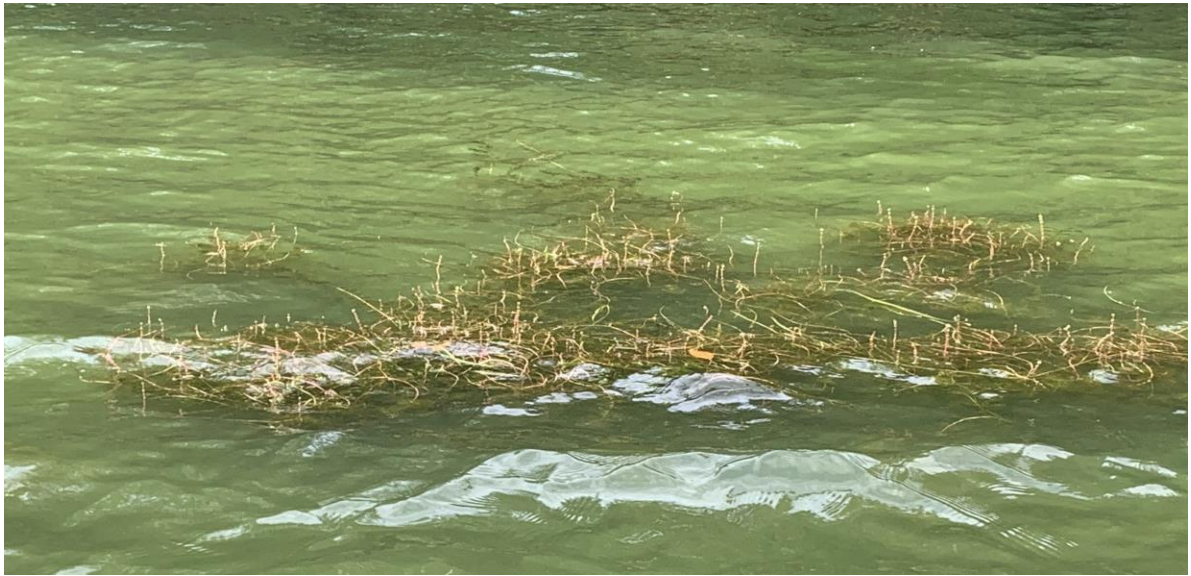
**Figure 4: Hybrid watermilfoil bed with flowers in the South Basin on Sept. 10, 2023**

A fall HWM survey completed on September 10, 2023, was timed perfectly for identifying HWM. It is usually very difficult to accurately document the location of HWM during the fall survey due to large amounts of native, Northern watermilfoil (NWM) that is present at the same time. However, during the Sept 10 survey, HWM was in its flowering stage with flower heads sticking out of the water several inches wherever HWM were found (Figure 4). Every HWM bed located had flowers, regardless of size. NWM does not produce flower heads, so it was clear that the beds were HWM.

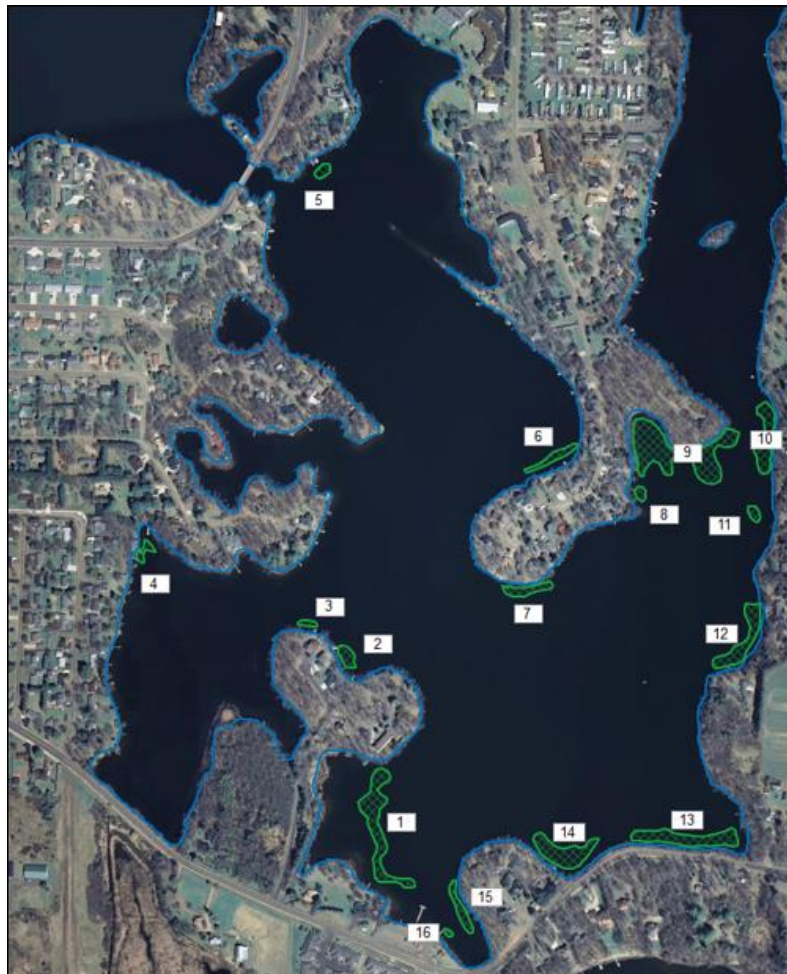
**Figure 5: 2023 fall HWM survey locations in the south basin**

Since HWM was found in at least 16 different locations in the South Basin (Figure 5) and because it was so easy to identify, the RLPRD was encouraged by its consultant to hire a scuba diving company to remove as much HWM from the new beds as they could before the end of the month (September 2023).

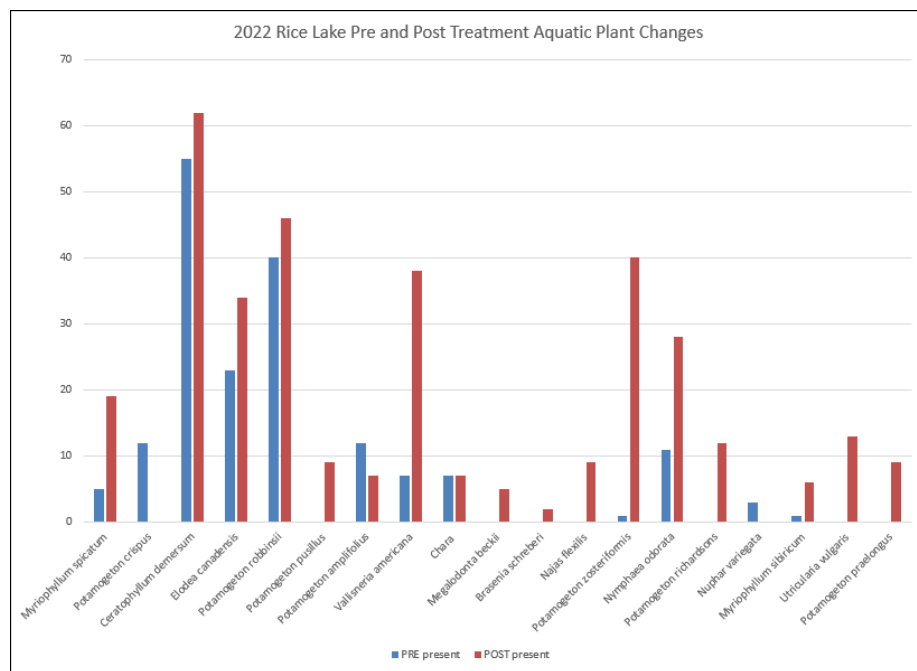
**Figure 7: 2022 Pre and post-treatment aquatic plant changes in Rice Lake, Barron County**

The 100 points were again surveyed in early September 2022 by LEAPS. During the post-treatment survey, 17 different aquatic plant species including HWM but not CLP were found. Unfortunately, the amount of HWM increased significantly between the pre- and post-treatment survey. Fall 2022 HWM bed mapping suggested that the amount of HWM was down in the 2022 areas treated with ProcellaCOR, but up substantially in areas that were not chemically treated. Table 1 compares the statistics from the pre and post survey. Figure 7 shows the changes in aquatic plants between the two surveys. All the data from the post-treatment survey is higher than that from the pre-treatment survey, suggesting the treatment had little impact on either HWM or native aquatic plants. CLP is down between the two surveys, but this is likely due to it being too late in the season to find CLP.

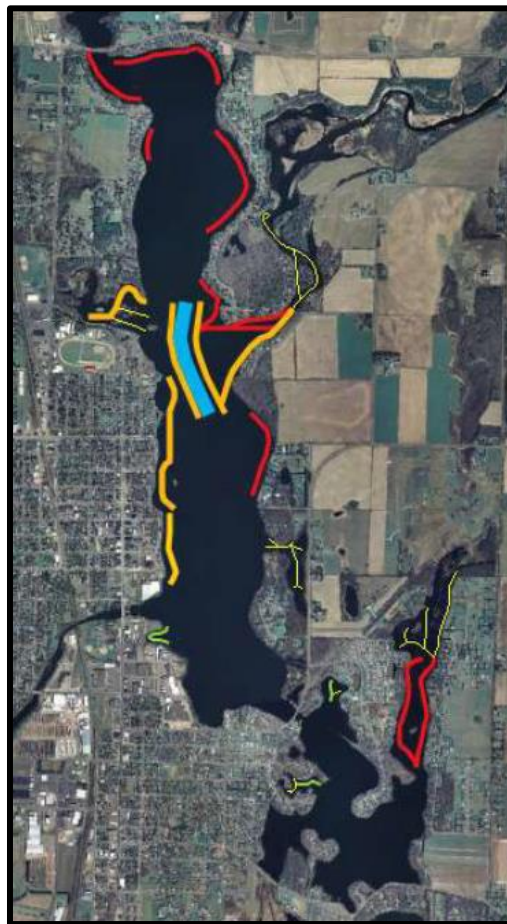
**Figure 8: 2022 Rice Lake navigation lanes**

In addition to harvesting CLP from the lake, and additional 66 acres of navigation lanes and channels are kept open through harvesting during the summer. Table 2 and Figure 8 reflect what is usually harvested once the CLP season ends.

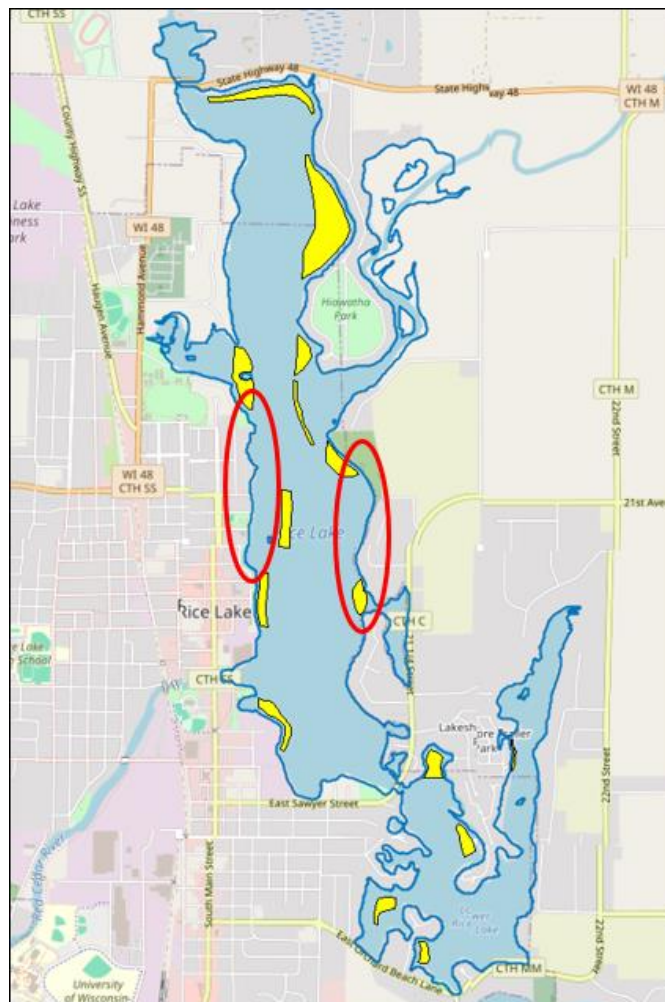
Figure 9: 2023 CLP bed mapping (red circles represent areas previously treated with herbicides)

Mapping of CLP was again completed by RLPRD volunteers in 2023. Their data was then turned into maps by their consultant. In 2023, 15 beds of CLP were mapped totaling 73.35 acres (Figure 9). Some of these beds were lighter in density than others. Results showed that in the Big Bay area on the east side of the lake that was chemically treated in 2022, CLP was down substantially compared to those areas that were not chemically treated. CLP along the west shore (Lakeshore Dr) also remained low. It had been chemically treated three years ago (2021).

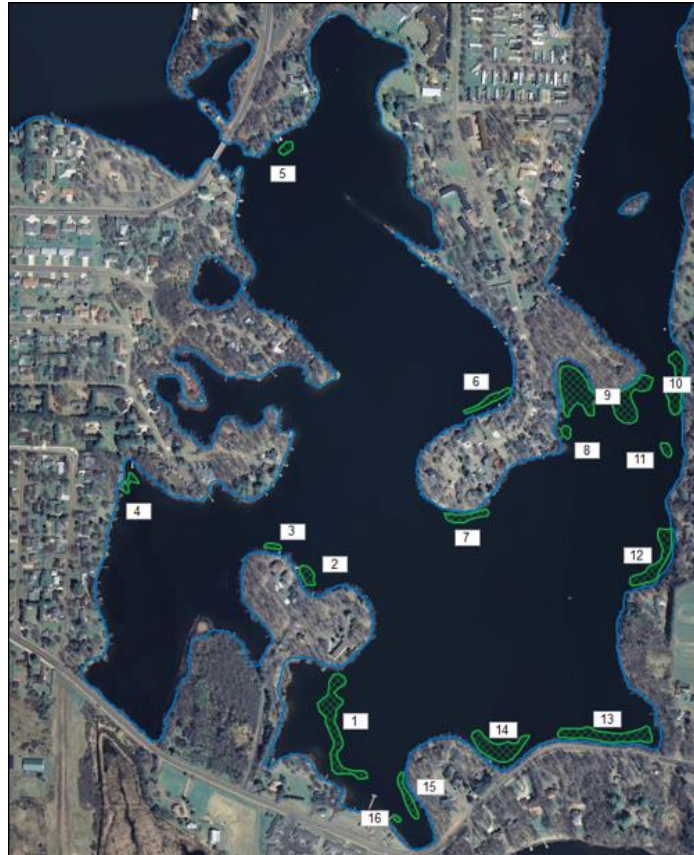
**Figure 10: 2023 HWM bed mapping results**

A 2023 fall HWM survey and bed mapping was completed by LEAPS on September 10, 2023. The timing of the survey ended up being perfect for finding new infestations of HWM. HWM flowers in the late summer, with small 1–3-inch flower heads sticking up out of the water. NWM does not flower, so there are no spikes sticking out of the water in a bed of NWM. Nearly every bed of HWM found had flowers sticking out of the water making it much easier to identify the two different plant species during the mapping. The bad news was that because HWM was so easy to identify, a lot of it was found. During the survey, 16 beds were found totaling 6.24 acres (Figure 10). Fortunately, no HWM was found outside of the south basin and clearwater bay, but it is likely just a matter of time. During the September 10<sup>th</sup> survey, a small bed of HWM was found just inside the South Basin from the narrows bridge (Bed 5).

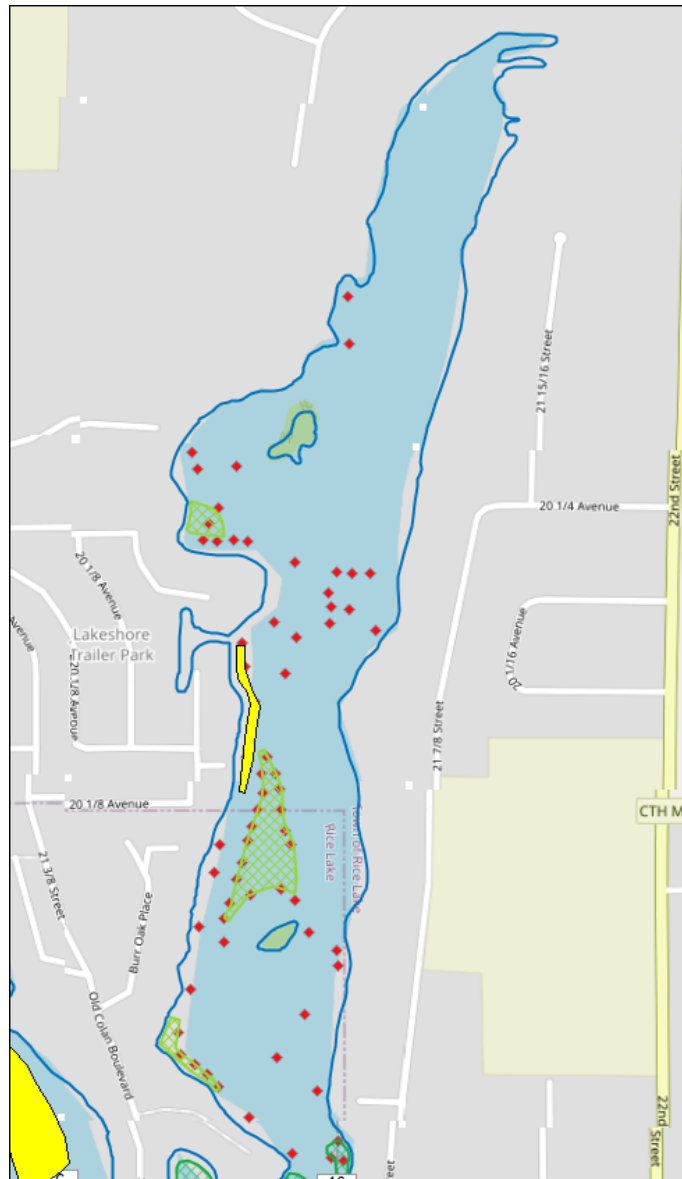
Figure 11: September 10, 2023 HWM meandering survey results in Clearwater Bay

In addition to what was found in the South Basin, Clearwater Bay continues to be overrun with HWM. During the September survey, 3 beds totaling 2.64 acres and literally hundreds of individual points were mapped (Figure 11). It is difficult to determine the bed management actions to be taken in Clearwater Bay as application of herbicides to the entire basin will likely take out many desirable native species along with the HWM. Physical removal is no longer effective at providing any level of control. Mechanical harvesting may be the best option available to the RLPRD is Clearwater Bay. Although it would do little to reduce the amount of HWM, it would at least keep the bay usable and navigable.

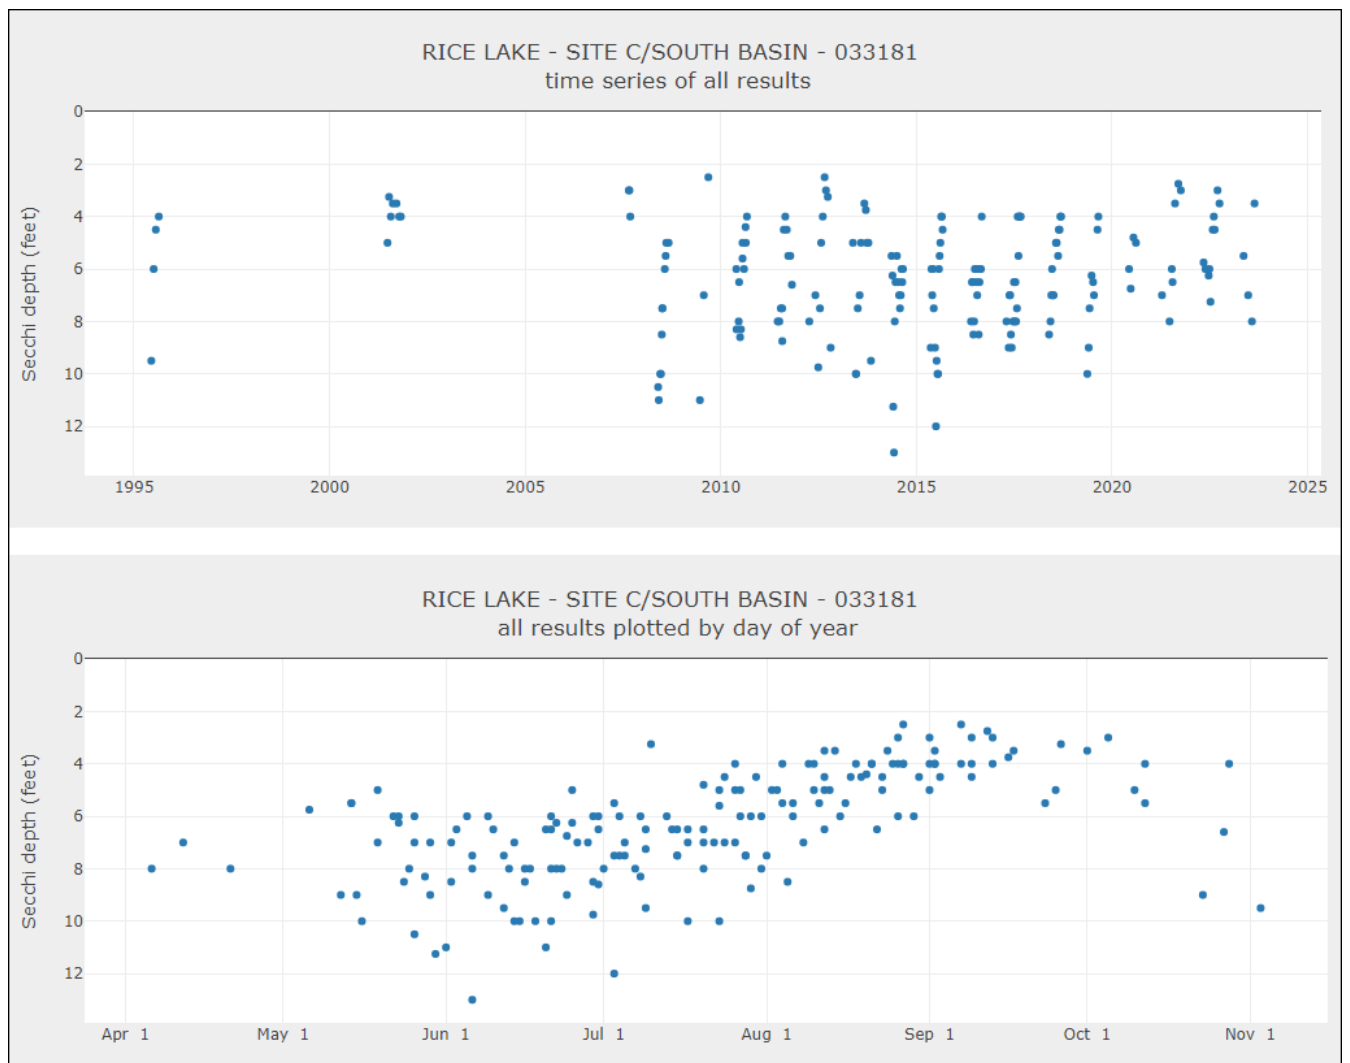
Figure 13: All Secchi disk readings of water clarity taken from the South Basin in Rice Lake (top); all Secchi disk readings through the open water season (bottom) (WEx, 2024).

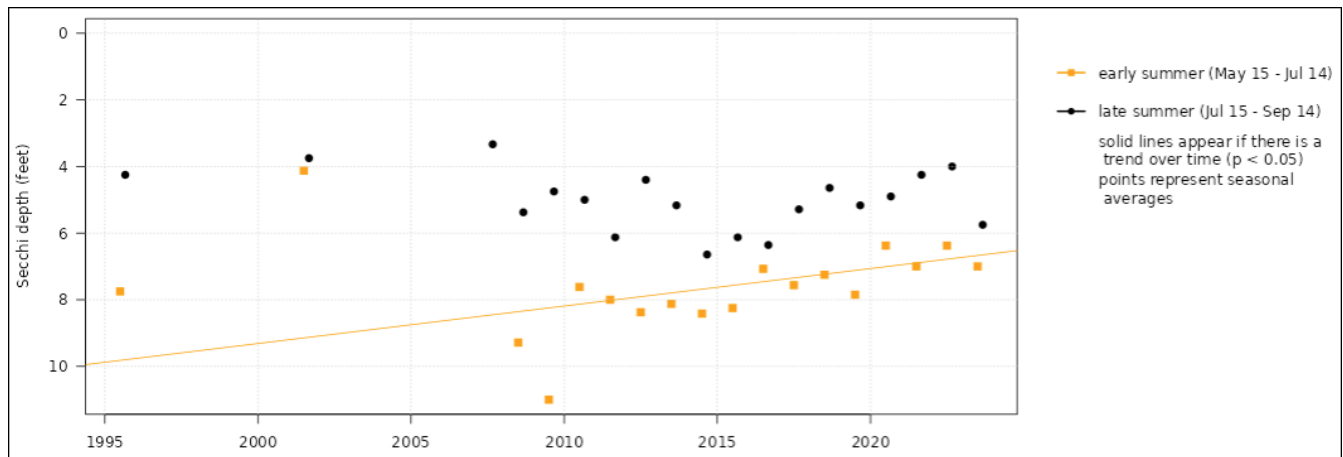
**Figure 14: Significant trends over time in water clarity in the South Basin of Rice Lake (WEx, 2024)**

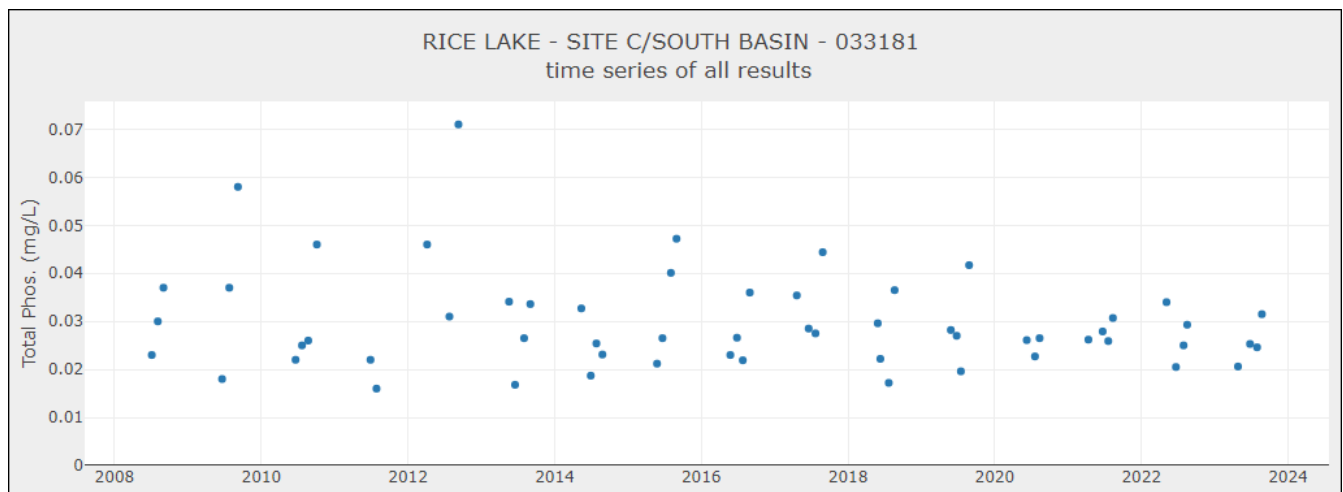
**Figure 15: All TP data collected from the South Basin of Rice Lake (WEx, 2024)**

Figure 15 shows all TP data collected from the South Basin since about 2008. Like with Secchi disk readings of water clarity, the only significant trend in TP is that the early summer concentrations are increasing (Figure 16). Increasing phosphorus is not ideal and can lead to worsening water quality.

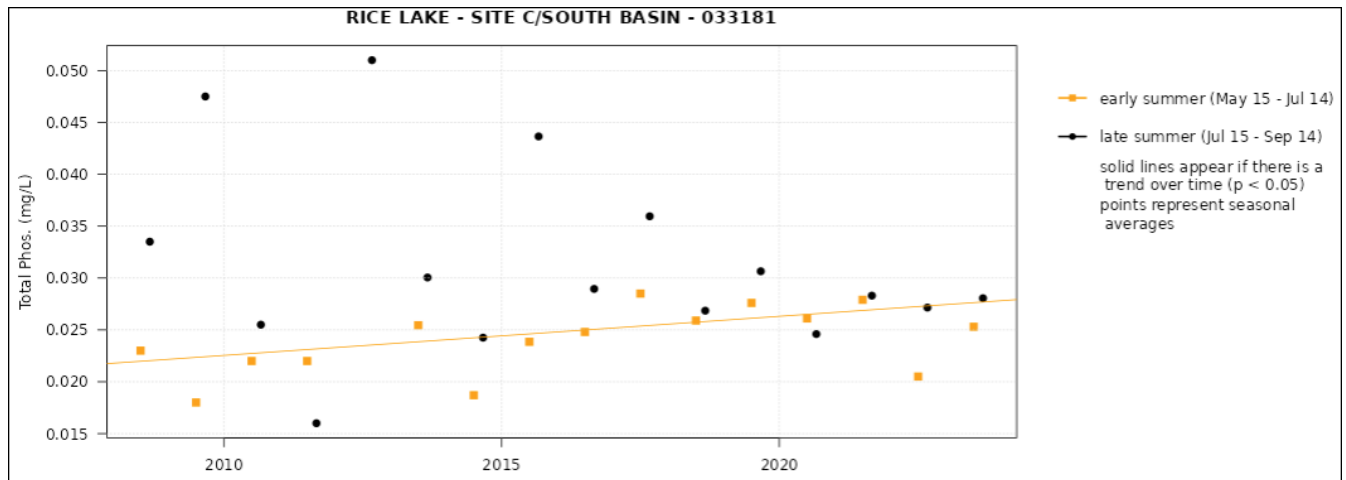
Figure 16: Significant trends in TP concentrations in the South Basin of Rice Lake (WEx, 2024)

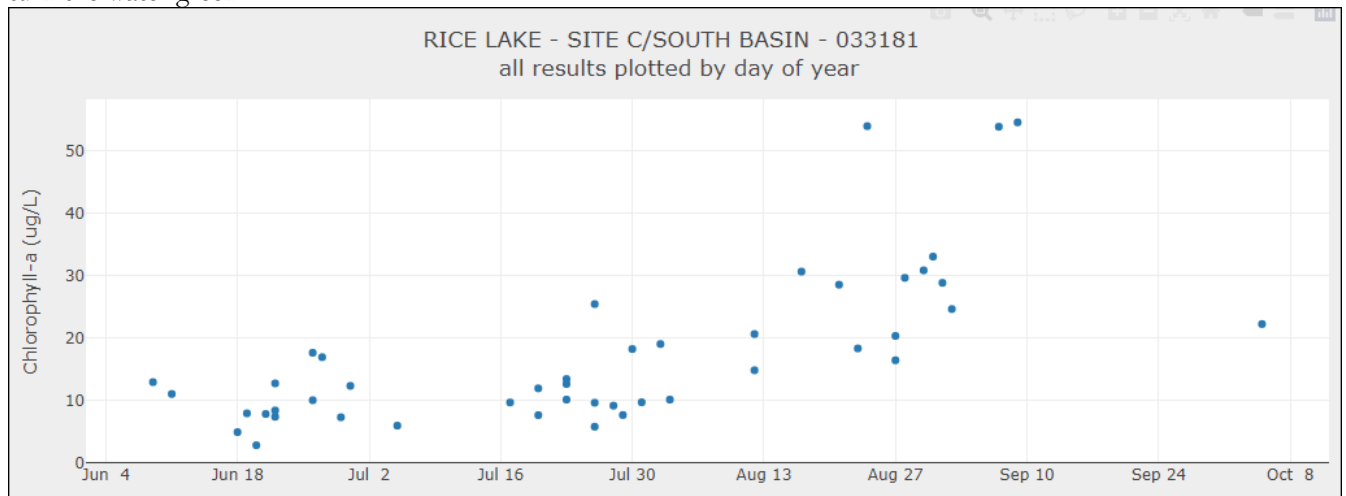
Figure 17: Seasonal Chla concentrations in the South Basin of Rice Lake (WEx, 2024)

Chla concentrations in the South Basin increase rapidly in late July (Figure 17), again primarily due to nutrient release from the bottom sediments of the lake. And like Secchi disk readings of water clarity and TP, the only significant trend is an increasing one in the early summer (Figure 18). Increasing levels of Chla indicate more algae in the lake to turn the water green.

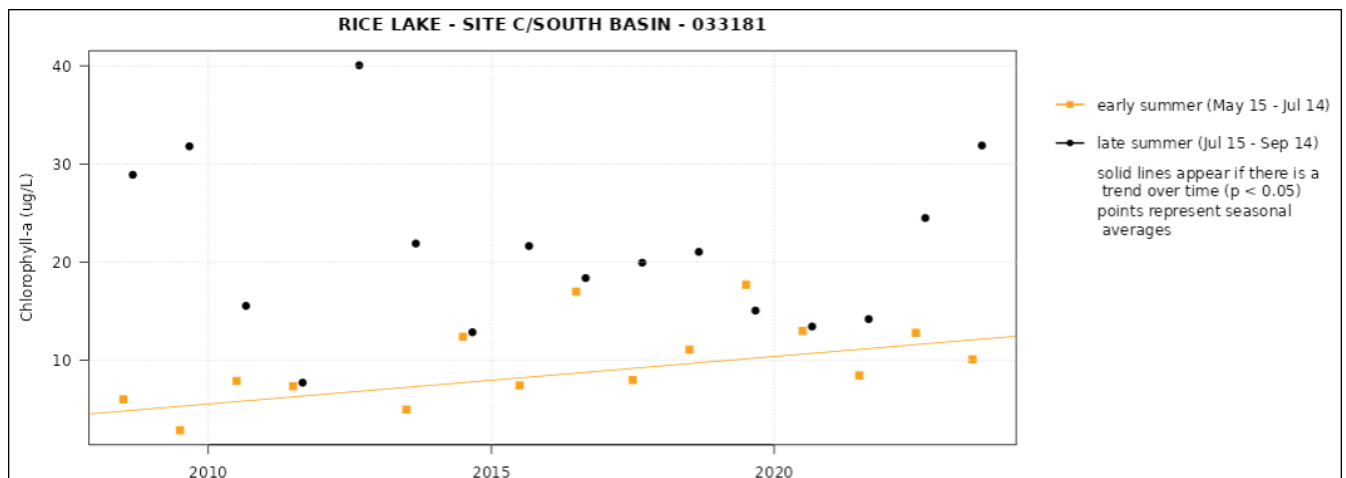
Figure 18: Significant trends in Chla from the South Basin of Rice Lake (WEx, 2024)

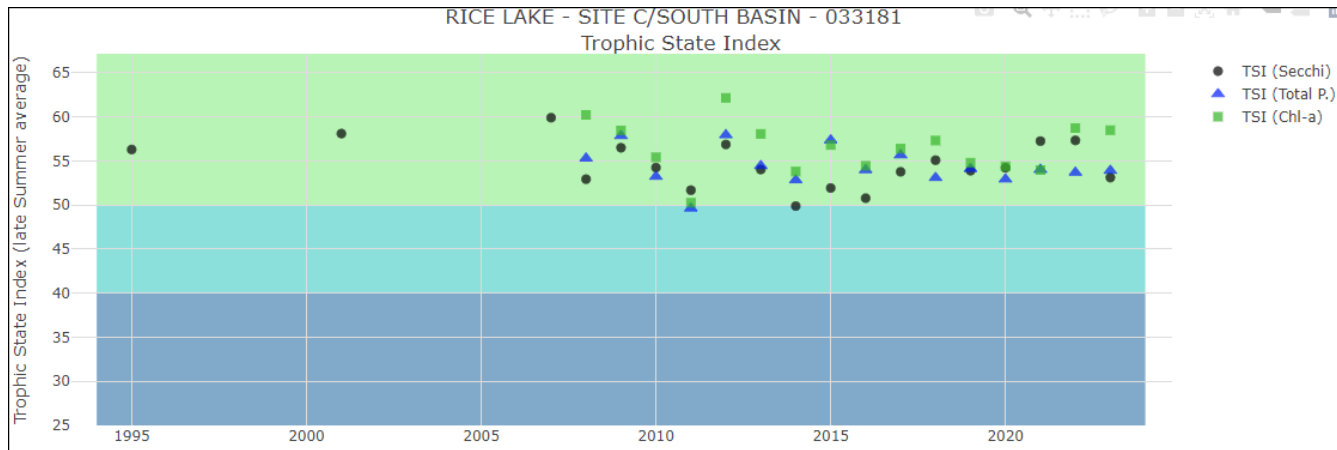
**Figure 19: Historical TSI values for water clarity, total phosphorus, and chlorophyll-a at the South Basin in Rice Lake (WEx, 2024)**

All three parameters – Secchi disk readings of water clarity, TP, and Chla can be combined in one formula and put in a Trophic State Index (TSI) scale from 0-100. The TSI equations use late summer (July 15 - September 15) averages of Secchi depth, total phosphorus, and chlorophyll- $\alpha$ . Values greater than 50 are considered Eutrophic and may lead to excess nutrients, lower water clarity, and greater risk of harmful algal blooms and hypoxia (low oxygen). Values between 40 and 50 are considered Mesotrophic with moderate levels of nutrients and moderate water clarity. Values less than 40 are considered Oligotrophic with low levels of nutrients, high water clarity, and lower risk of hypoxia. Figure 19 represents all TSI data for the South Basin in Rice Lake. Nearly all of the data collected puts the South Basin of Rice Lake in the eutrophic category for lakes.

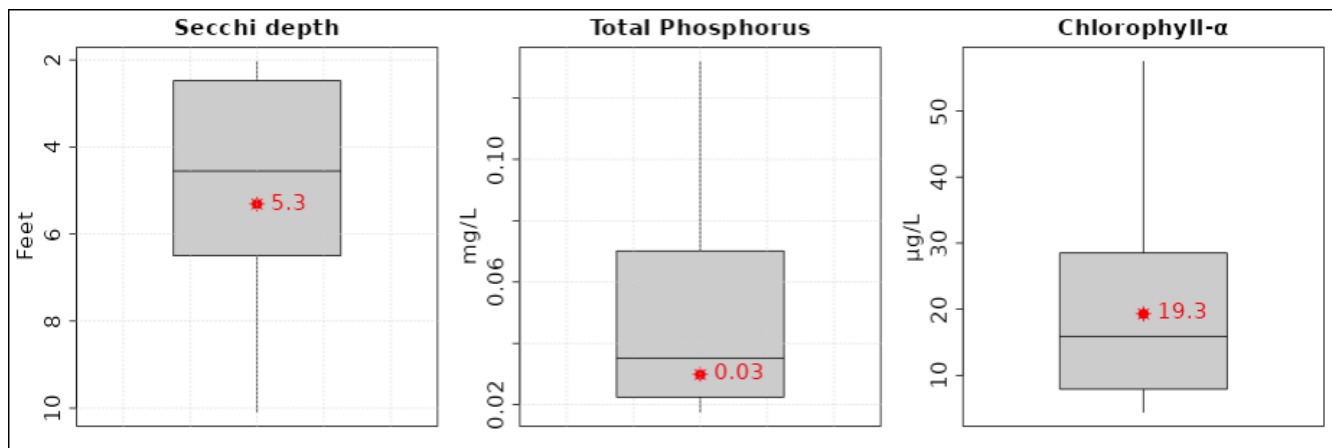
**Figure 20: Water quality parameters from the South Basin of Rice Lake compared to other similar lakes (WEx, 2024)**

When late summer trophic indicator averages (red) from the South Basin from the last 10 years are compared to other reservoir lakes like Rice Lake (Figure 20), we see that Rice Lake is better than average for Secchi and TP, and worse than average for Chla.

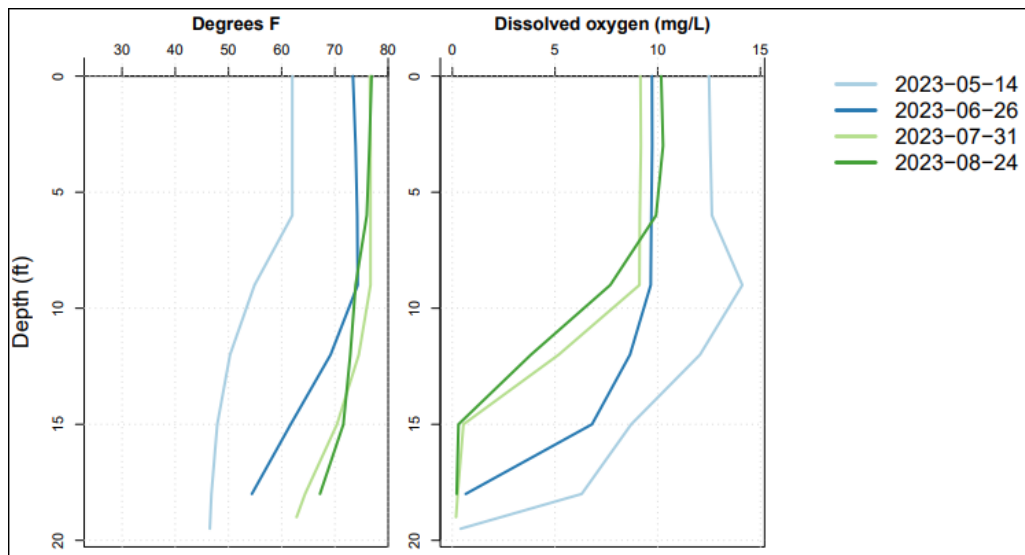
Figure 21: Temperature and DO profiles from the South Basin of Rice Lake (WEx, 2024)

somewhere in the 10-15ft depth beginning in late July (Figure 21) and last through late September and early October before the layers break down and mix again.

With little or no DO in the bottom waters of the South Basin, a chemical reaction occurs between iron and phosphorus that allows phosphorus formally trapped in the bottom sediments to be released back into the water column. This is what generally leads to the algae blooms and very green water in Rice Lake in the summer.

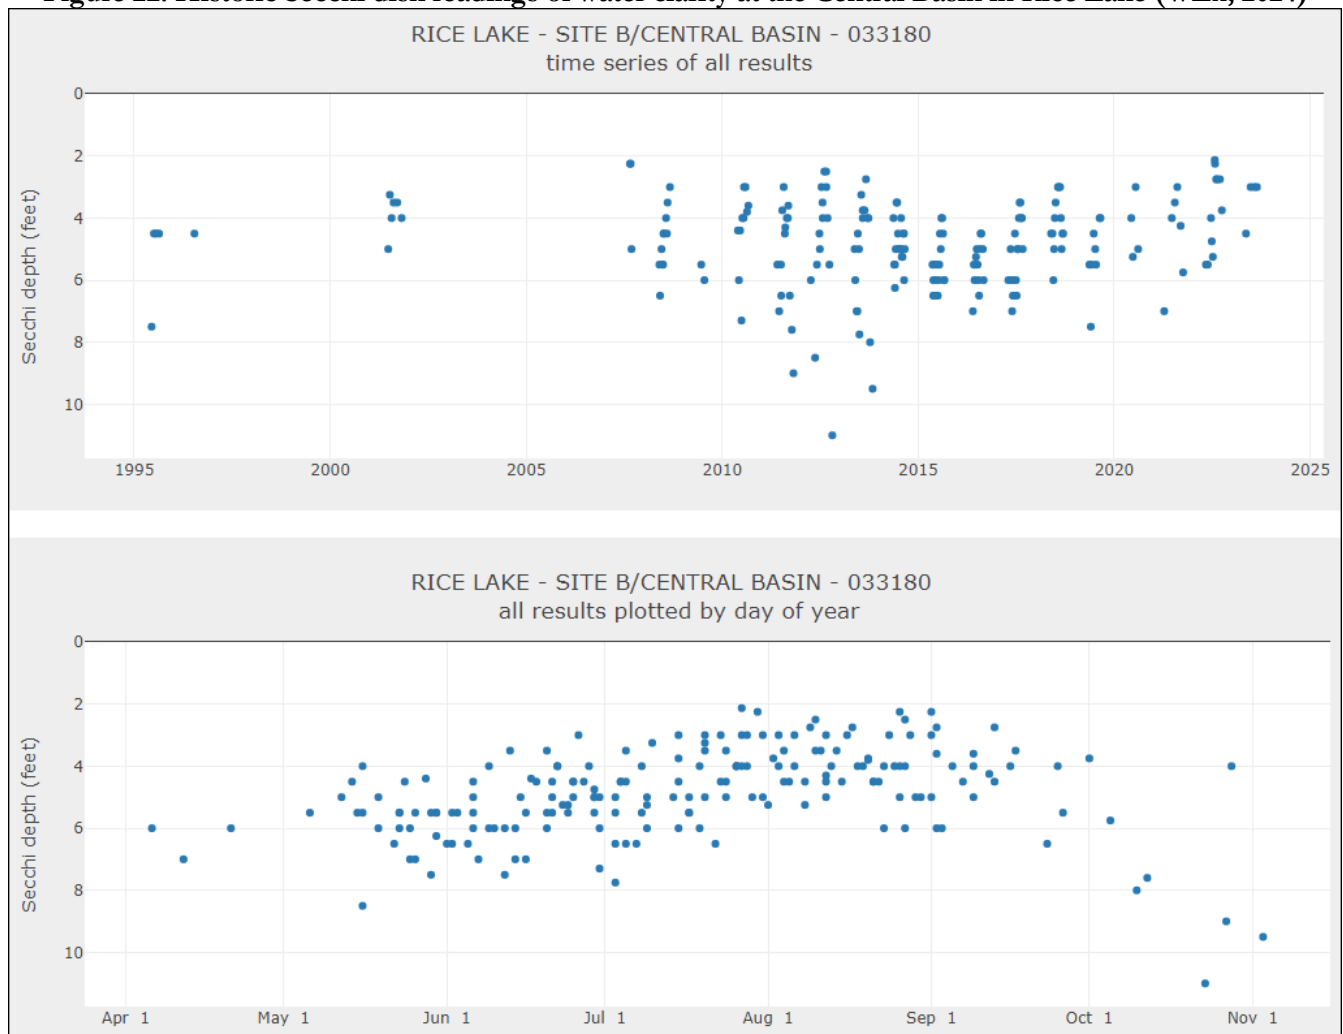
**Figure 23: All Secchi disk readings of water clarity taken from the Central Basin in Rice Lake (top); all Secchi disk readings through the open water season (bottom) (WEx, 2024).**

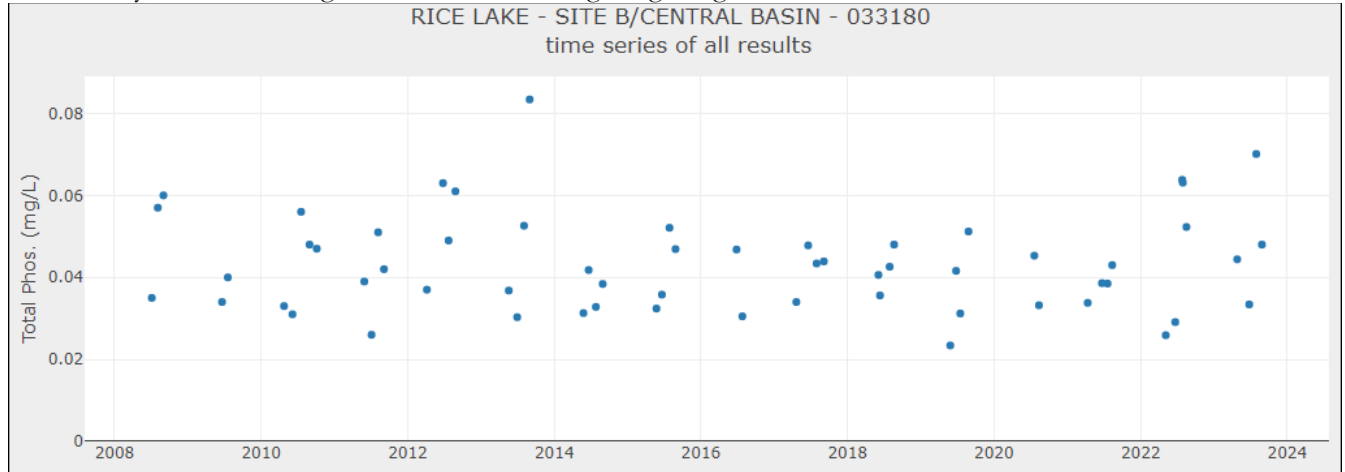
**Figure 24: All TP data collected from the Central Basin of Rice Lake (WEx, 2024)**

Figure 24 shows all TP data collected from the Central Basin since about 2008. Like with Secchi disk readings of water clarity, there are no significant trends showing TP getting better or worse in the Central Basin.

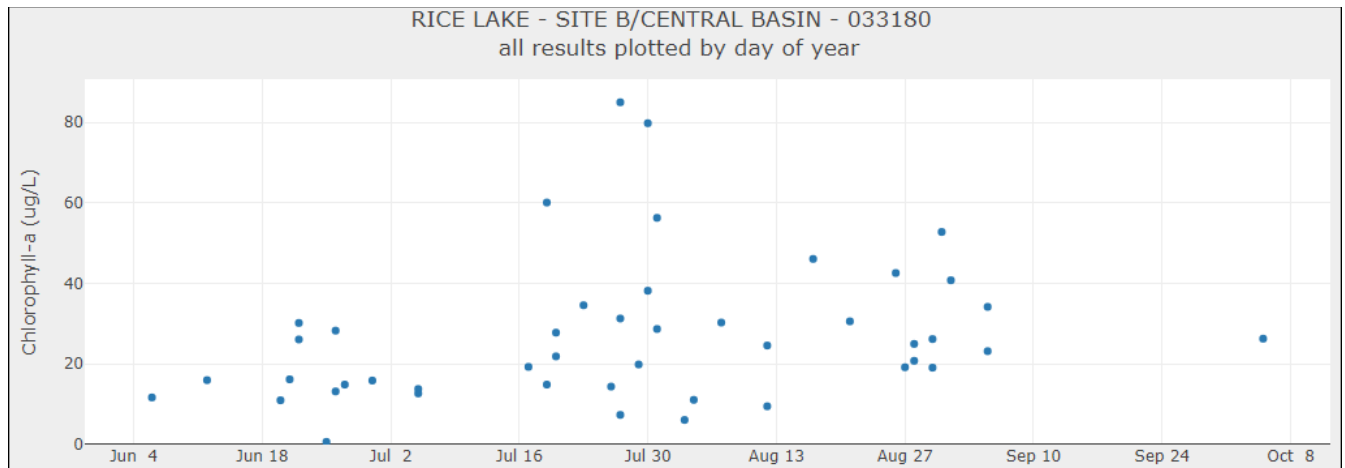
**Figure 25: Seasonal Chla concentrations in the Central Basin of Rice Lake (WEx, 2024)**

Chla concentrations in the Central Basin remain consistent throughout most of the summer season (Figure 25). This is due in part to the continuous flow of water through the Central Basin flushing out the algae over the dam into the Red Cedar River downstream. Early summer Chla is the only parameter that shows any significant trend to report. Unfortunately, like in the South Basin, Chla in the Central Basin shows a significant trend toward higher or worsening concentrations in the early summer (Figure 26).

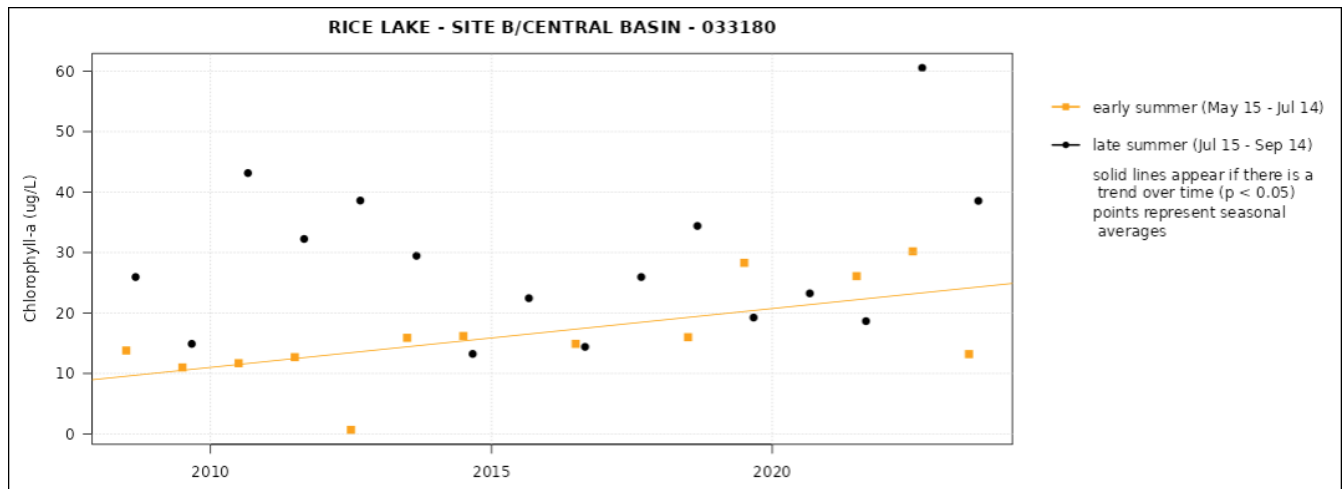
**Figure 26: Significant trends in Chla from the Central Basin of Rice Lake (WEx, 2024)**

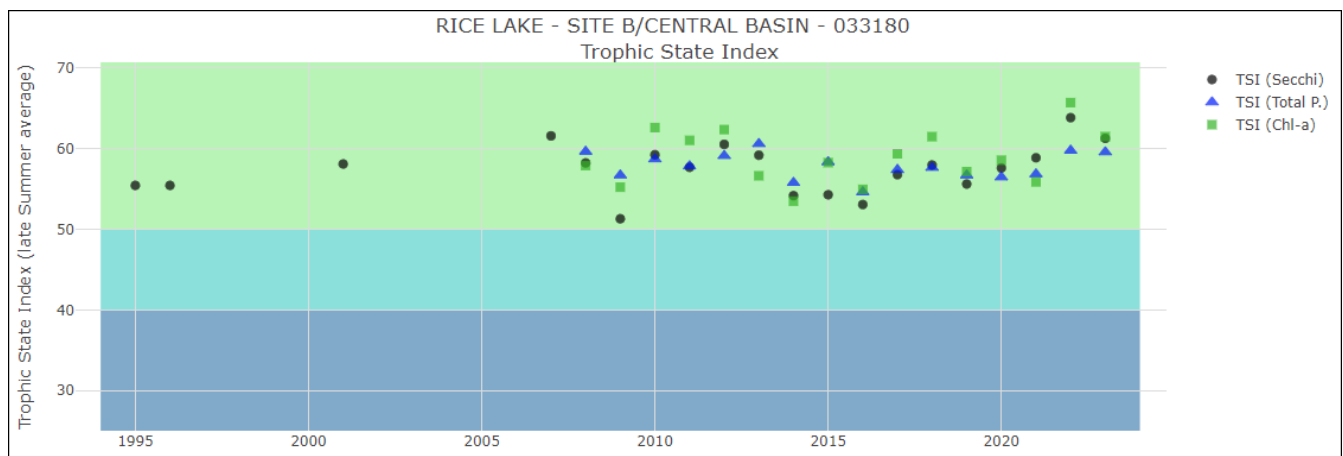
**Figure 27: Historical TSI values for water clarity, total phosphorus, and chlorophyll-a at the Central Basin in Rice Lake (WEx, 2024)**

All three parameters – Secchi disk readings of water clarity, TP, and Chla can be combined in one formula and put in a Trophic State Index (TSI) scale from 0-100. The TSI equations use late summer (July 15 - September 15) averages of Secchi depth, total phosphorus, and chlorophyll- $\alpha$ . Values greater than 50 are considered Eutrophic and may lead to excess nutrients, lower water clarity, and greater risk of harmful algal blooms and hypoxia (low oxygen). Values between 40 and 50 are considered Mesotrophic with moderate levels of nutrients and moderate water clarity. Values less than 40 are considered Oligotrophic with low levels of nutrients, high water clarity, and lower risk of hypoxia. Figure 27 represents all TSI data for the Central Basin in Rice Lake. Nearly all the data collected puts the Central Basin of Rice Lake in the eutrophic category for lakes.

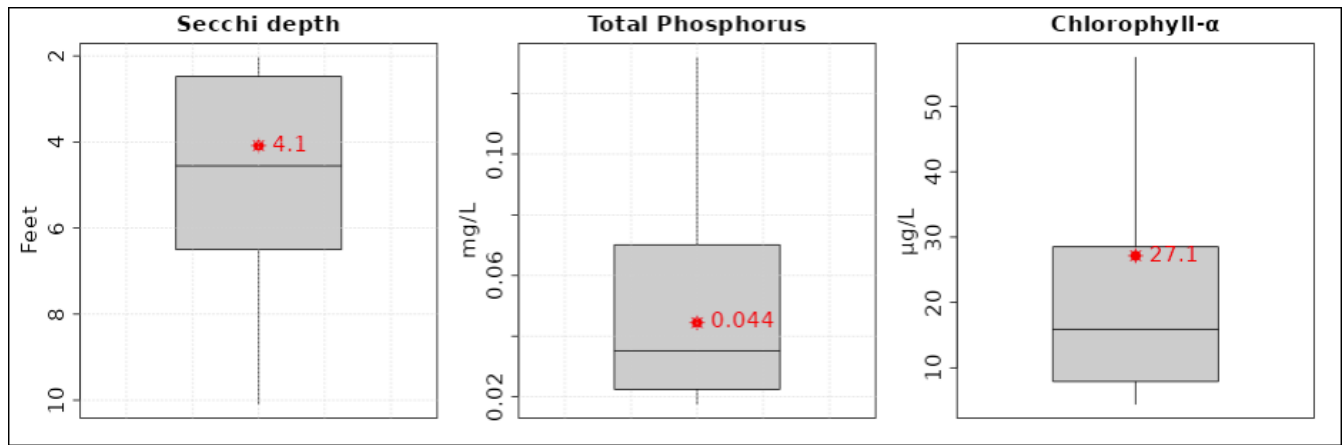
Figure 28: Water quality parameters from the Central Basin of Rice Lake compared to other similar lakes (WEx, 2024)

When late summer trophic indicator averages (red) from the Central Basin from the last 10 years are compared to other reservoir lakes like Rice Lake (Figure 28), we see that water quality in the Central Basin of Rice Lake is worse than average for Secchi, TP, and Chla.

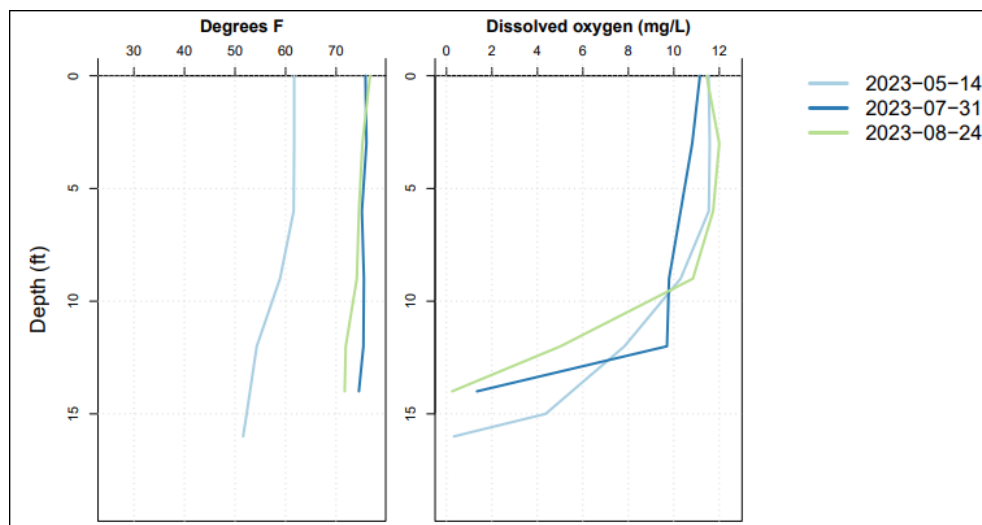
Figure 29: Temperature and DO profiles from the Central Basin of Rice Lake (WEx, 2024)

As mentioned, temp and DO profiles were collected from the Central Basin in 2023. Because of its depth and the fact that the river runs through it, the Central Basin does not stratify (Figure 29). DO levels do decrease starting at about 10ft.
