# RICE LAKE BARRON COUNTY

## 2023 MANAGEMENT SUMMARY REPORT WBIC: 2103900

Prepared by: Dave Blumer, Lake Educator

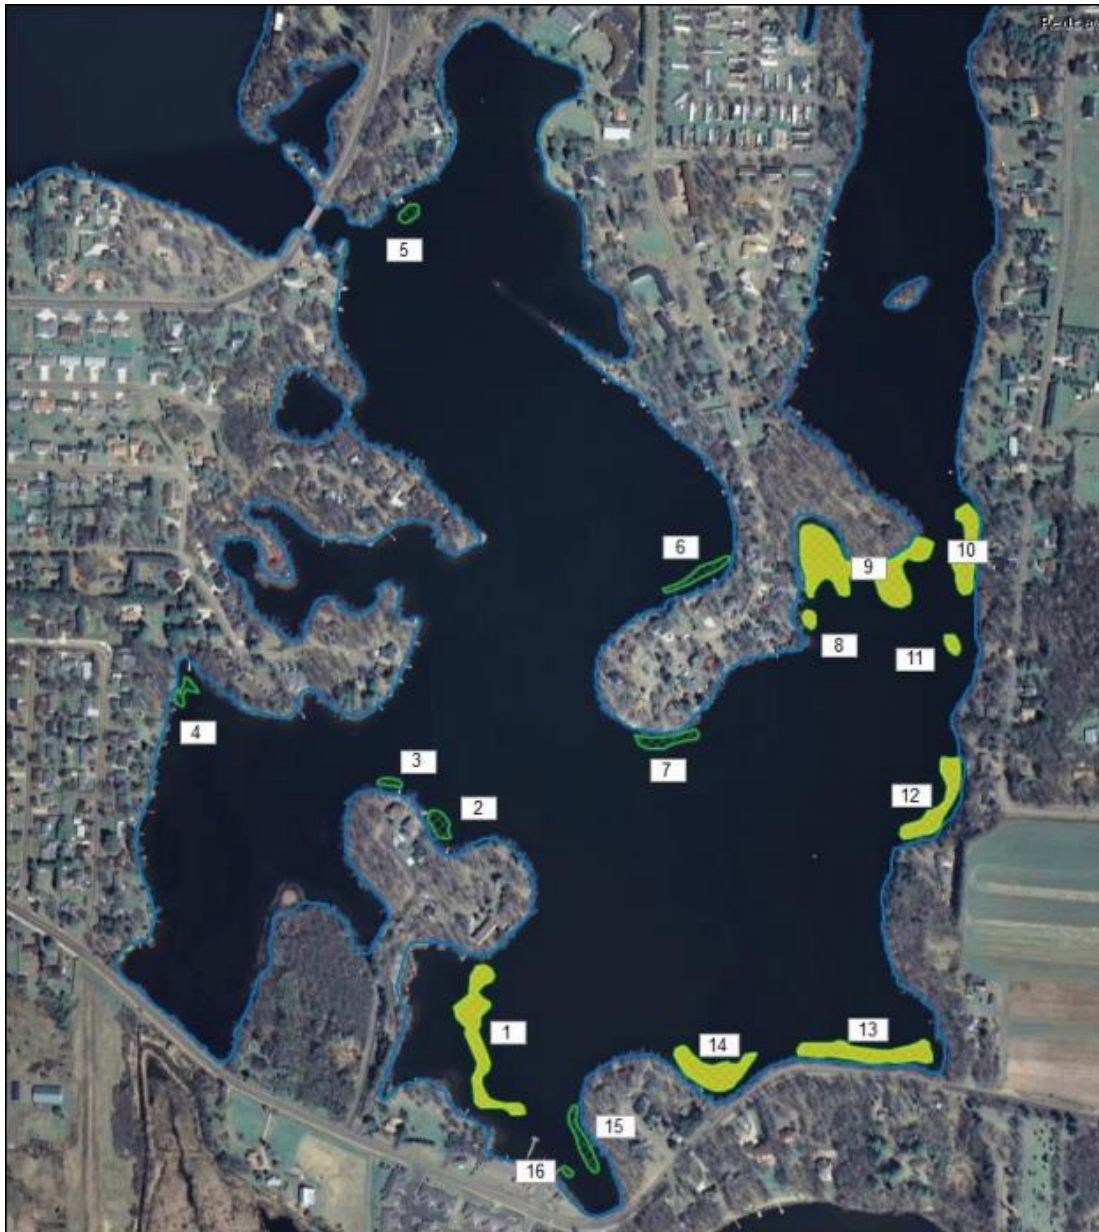
Figure 30: 2024 preliminary HWM herbicide application proposal

The current proposal for the South Basin includes four areas encompassing eight of the sixteen HWM beds identified in the Fall 2023 survey (Figure 30, Table 4). The other beds from that survey were managed with scuba diver removal in late September 2023. Follow-up monitoring will be done in those areas. Herbicide concentration testing is planned for after the 2024 ProcellaCOR application.
